## **Appendix C**

### **Photograph Log**

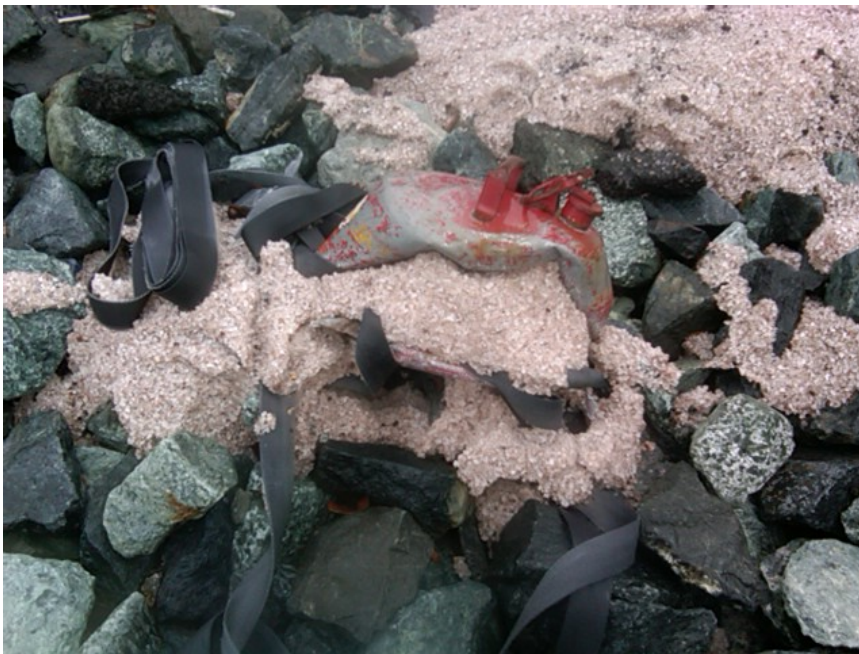
**Photograph 43.** Ritchie Service Facility – Gasoline container and salt located in stormwater management control structure shown in the previous photograph.
